Soft Bottom Mitigation Plan

Humboldt Island & Trinidad Island
Bulkhead Repair Project
Huntington Beach, California

Prepared By:
Tetra Tech, Inc.
670 N. Rosemead Blvd.
Pasadena, California

April 2000

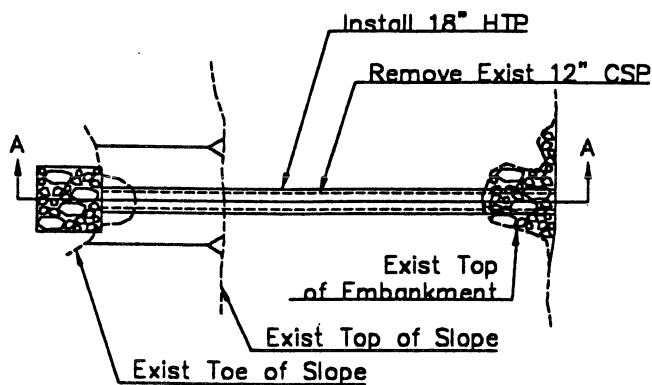
FIGURE 3

There is an existing wetland area adjacent to the southeast corner of Pacific Coast Highway and Warner Avenue which is fed by a 12-inch diameter conduit, that is 28-ft in length, connecting the wetland area to the channel at the east end (Figure 3. Conduit_Detail). This entrance conduit has corroded and broken, resulting in impedance of proper tidal flushing of the wetland. In addition, in the adjacent area located immediately south of the west end of this wetland area, there is a concrete foundation which is from a former structure that was removed decades ago. This concrete and the associated debris are occupying space that could otherwise function as wetland.

Conduit Restoration. Replace existing conduit with 18-inch diameter PVC conduit 28 feet in length. Install rip-rap around new conduit. Restore embankment where it has eroded to previous dimensions aligned with the surrounding channel embankment. The restoration of this conduit will create a tidal influence in the existing wetland area (Figure 3. Conduit Detail).

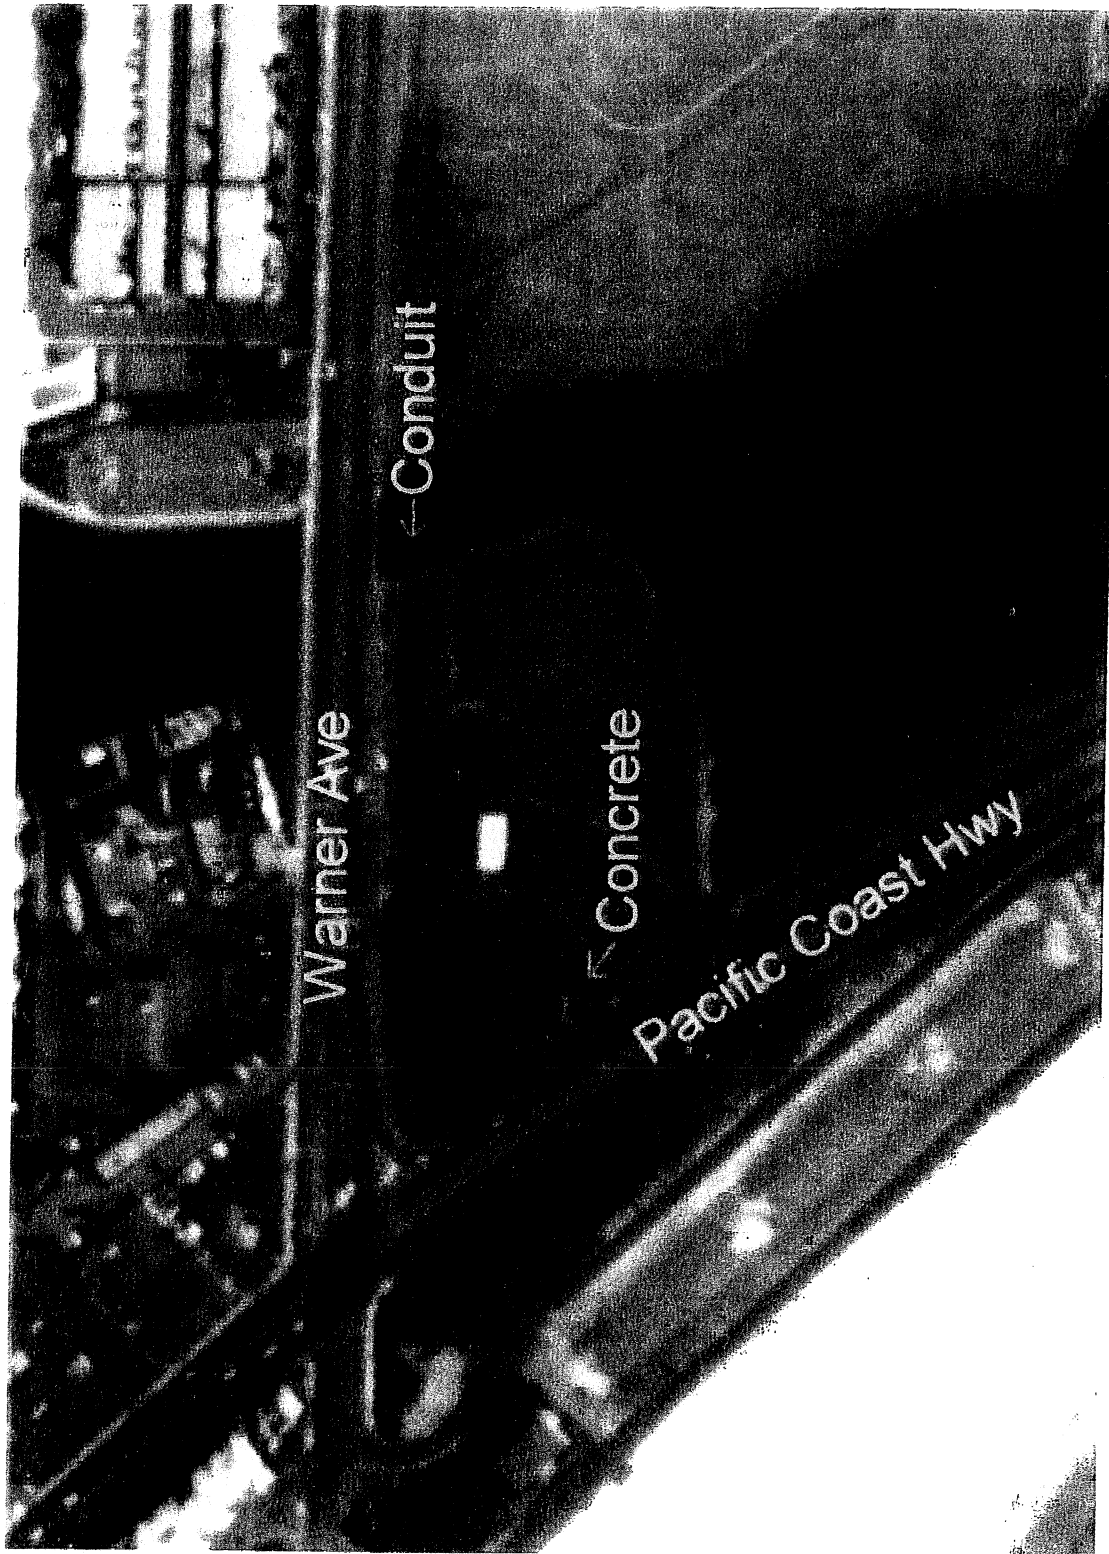
Photo 1. Aerial view of soft bottom mitigation site in Bolsa Chica Ecological Reserve depicting conduit repair location and concrete removal location, Soft Bottom Mitigation Plan, March 2000.

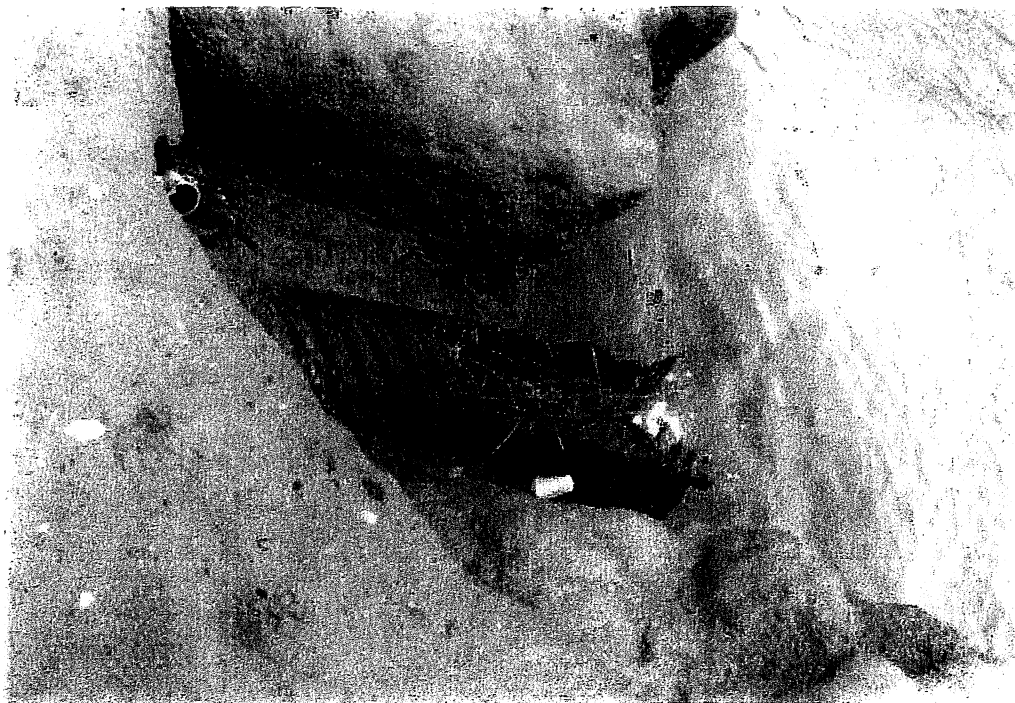
Photo 2. Conduit between channel and wetlands where replacement is proposed.

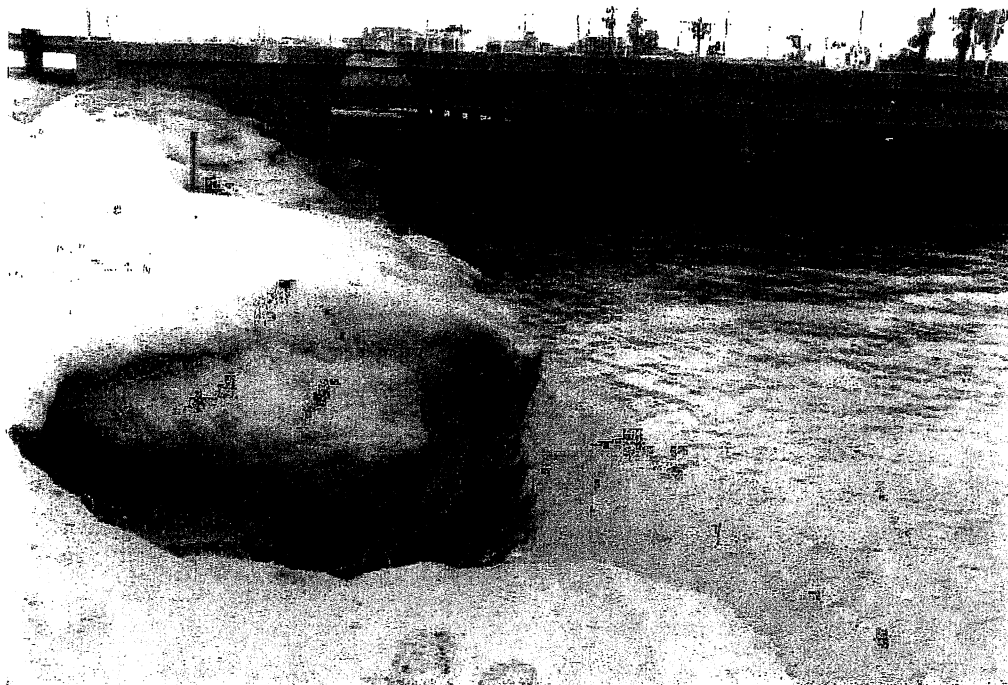
Photo 3. Erosion around conduit at channel where backfill is proposed.

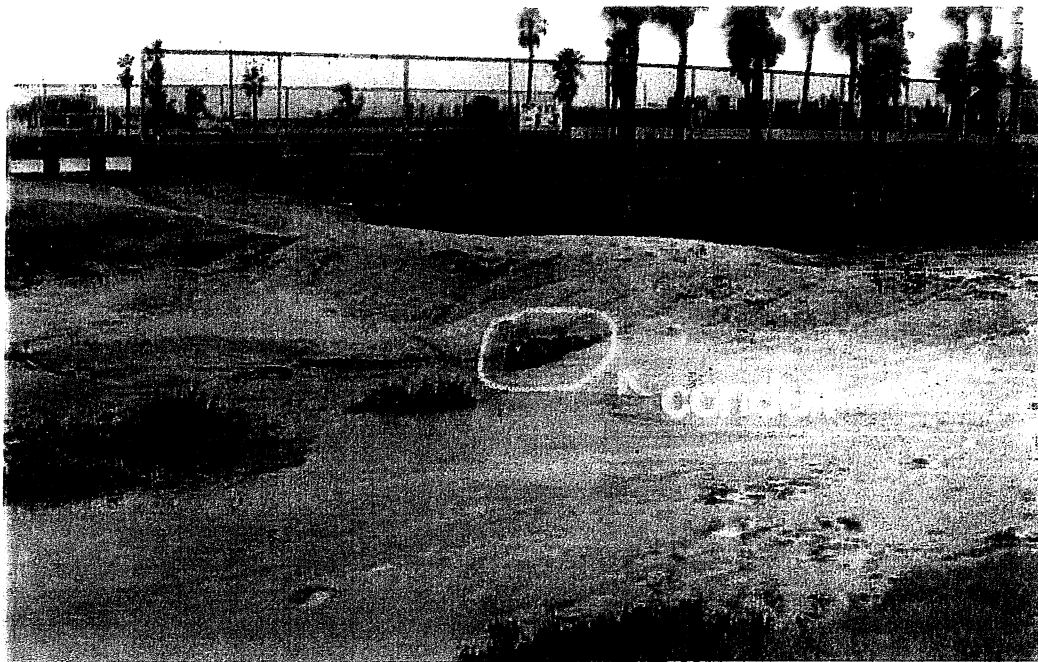
Photo 4. Wetland side of conduit between channel and wetlands where replacement is proposed.
